**Flood Control Project Maintenance
Levee Inspections**

Fall 2016 Levee Maintenance Deficiency Summary Report

Sacramento River Basin

Reclamation District No. 1001 Nicolaus

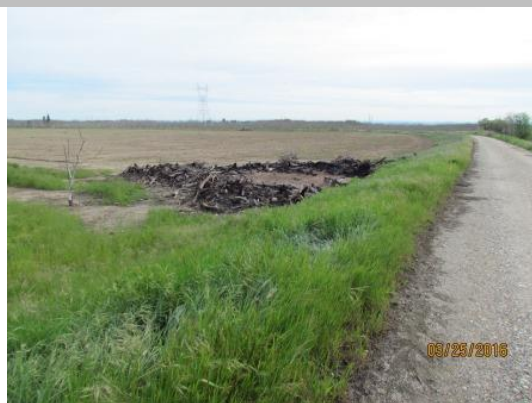
Photo 1 of 2 : FA_2016_RD1001_36_14_20160906_00009.jpg

View of pruning after burning Spring 2016.

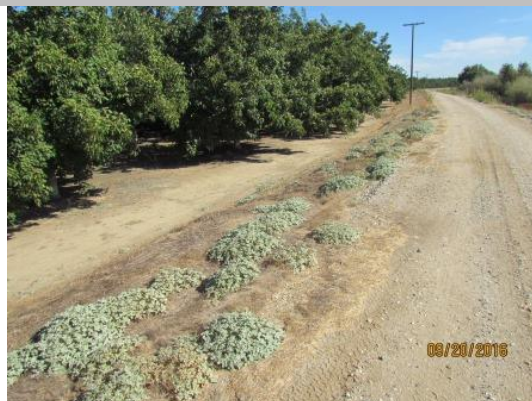
Photo 1 of 1 : FA_2016_RD1001_36_25_20160926_00029.jpg

LM Start	1.40	Rating **	M	Issue No.	25
LM End	1.40	Issue Type +	Ma	Location *	LS
Category	Earthen Levee			GPS Latitude/Longitude	
				Start	End
Item	Slope Stability			38.971589 °	38.971589 °
				-121.492049 °	-121.492049 °
DWR ID	DWR_RD1001_01_f_2016_25				
Comment Code					
S3 : Repair the levee slope damaged by vehicle traffic and prevent access where possible.					
Inspector Comment

View of tier ruts on the landside levee slope looking upstream. Fall 2016.

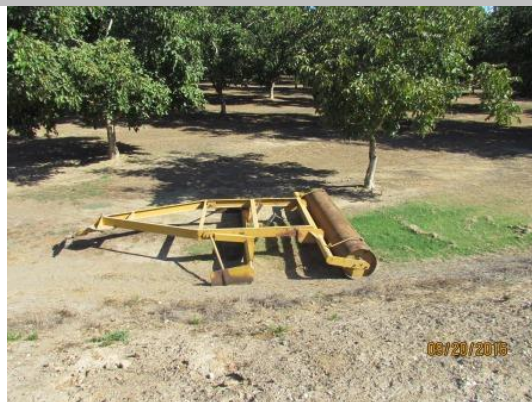
Photo 1 of 1 : FA_2016_RD1001_36_23_20160926_00027.jpg

View of equipment at the landside levee toe. Fall 2016.

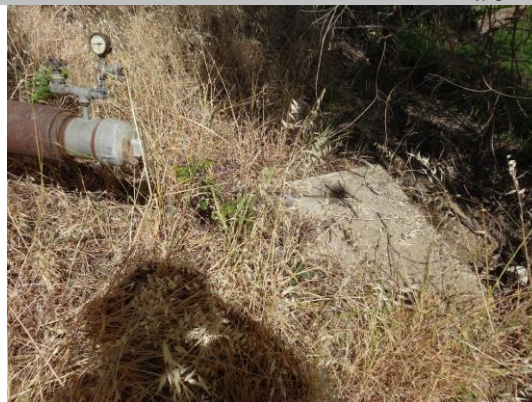
Photo 2 of 2 : UCIP_FA_2016_41673_22744.jpg

Comment Code					
Inspector Comment					
FS_ID:41673					
DS_ID:22536					
EP_NO: 5562					
Repair Type: Non-Urgent					
Crossing Status: Found					
UCIP Comments: Pipe appears abandoned and if so should be done so properly. WS pipe plugged with stopper. Seems abandoned. Only abandoned pump base found.					
FIELD_STRUCT_DESC: 6-inch steel irrigation pipe through the levee, 3.5 feet below the crown, pump (removed) and pump base on the waterward berm, siphon breaker on the landward shoulder, pipe discharges into underground irrigation system on the landward side. Power pole and meter box 10 feet from the landward toe, 1-1/2-inch flexible conduit through levee, 3.5 feet below crown (Permit No. 5562, 1966)					
FS Date: 5/23/2013

WS- plugged pipe and pump base.

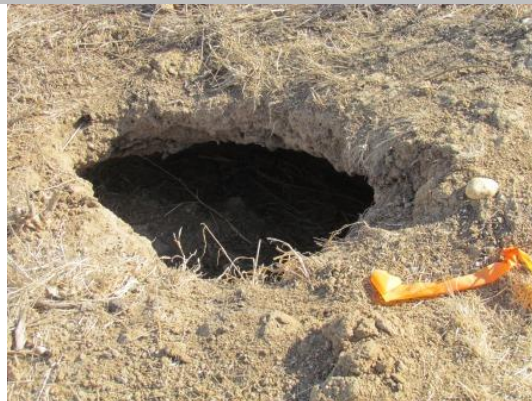
Photo 2 of 3 : FA_2016_RD1001_35_4_20160906_00002.jpg

LM Start	0.27	Rating **	A/W	Issue No.	4
LM End	0.27	Issue Type +	Ma	Location *	WS
Category	Earthen Levee			GPS Latitude/Longitude	
				Start	End
Item	Animal Control			38.974323 °	38.974323 °
				-121.476442 °	-121.476442 °
DWR ID	DWR_RD1001_02_f_2014_4				
Comment Code					
A3 : No rodents visible, but rodent burrows visible; need to backfill and compact or grout burrows.					
Inspector Comment					
There is no animal activity at this location, the existing hole near the crown needs to be repaired, Fall 2016.

Another picture of the animal burrow. Fall 2014.

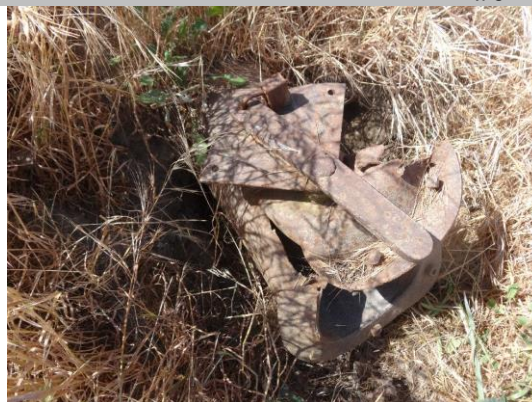
Photo 1 of 2 : UCIP_FA_2016_50740_22753.jpg

Comment Code					
Inspector Comment					
FS_ID:50740 DS_ID:22529 EP_NO: 2281 Repair Type: Non-Urgent Crossing Status: Not Found UCIP Comments: 07/13/2016 According to district president Joe Henderson, pipe was removed 2-3 years ago. No permit for removal found or evidence of pipe or its removal found. (K. Fazel - UCIP)05/23/2013:- leaky pipe end and erosion on WS.- cracked dirt mound on LS - seems not been used for some time. (P. Amatya - DWR) FIELD_STRUCT_DESC: *REMOVED* 8-inch steel irrigation pipe through the levee, 1.9 feet below the crown. Portable pump mounted on the bank during the summer months. Control valve on the waterside (WS), steel plate bolted on the WS end during the winter months. Pipe discharges into a 30-inch concrete standpipe at the landside (LS) toe. (Permit No. 2281, 1956 - Brown) [Additional Reference(s): DWR Levee Log, 1993]. FS Date: 7/13/2016

WS- end of the pipe.

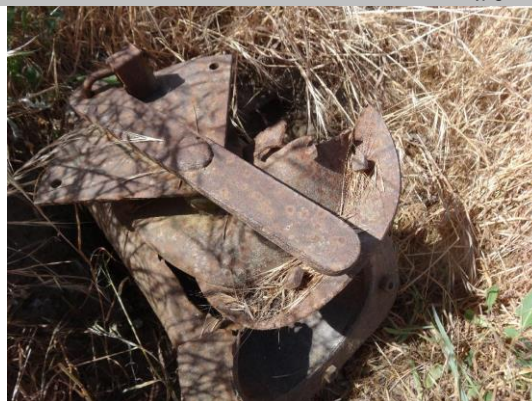
Photo 2 of 2 : UCIP_FA_2016_50740_22752.jpg

Comment Code						
Inspector Comment						
FS_ID:50740 DS_ID:22529 EP_NO: 2281 Repair Type: Non-Urgent Crossing Status: Not Found UCIP Comments: 07/13/2016 According to district president Joe Henderson, pipe was removed 2-3 years ago. No permit for removal found or evidence of pipe or its removal found. (K. Fazel - UCIP)05/23/2013:- leaky pipe end and erosion on WS.- cracked dirt mound on LS - seems not been used for some time. (P. Amatya - DWR) FIELD_STRUCT_DESC: *REMOVED* 8-inch steel irrigation pipe through the levee, 1.9 feet below the crown. Portable pump mounted on the bank during the summer months. Control valve on the waterside (WS), steel plate bolted on the WS end during the winter months. Pipe discharges into a 30-inch concrete standpipe at the landside (LS) toe. (Permit No. 2281, 1956 - Brown) [Additional Reference(s): DWR Levee Log, 1993]. FS Date: 7/13/2016

WS- seems abandoned or not been used for some time.

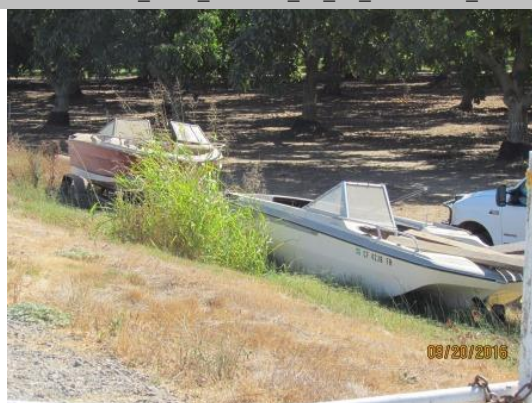
Photo 1 of 1 : FA_2016_RD1001_35_19_20160926_00023.jpg

LM Start	0.53	Rating **	M	Issue No.	19
LM End	0.53	Issue Type +	En	Location *	LS
Category	Earthen Levee			GPS Latitude/Longitude	
				Start	End
Item	Encroachments			38.974371 °	38.974371 °
				-121.481223 °	-121.481223 °
DWR ID	DWR_RD1001_02_f_2016_19				
Comment Code					
AV : Abandoned vehicles					
Inspector Comment					
Two boats parked at the landside levee toe that need to be removed.

View of two boat at the landside levee toe. Fall 2016.

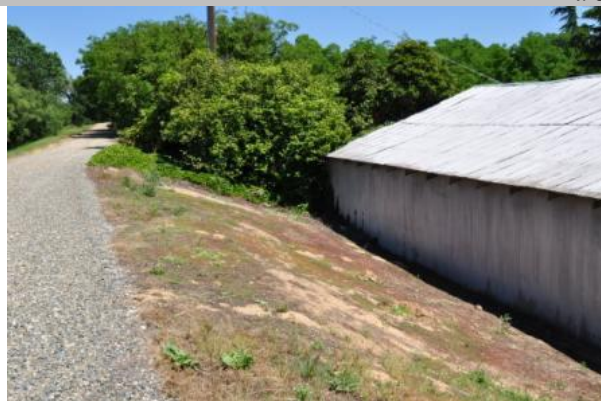
Photo 1 of 1 : FA_2016_RD1001_35_11_20160906_00006.jpg

RD 1001 Unit 2 - L/S -Building @ toe.

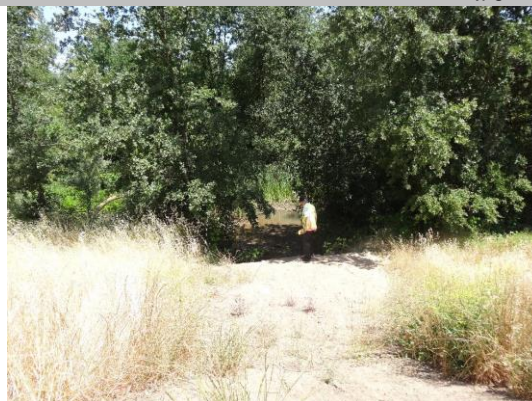
Photo 1 of 2 : UCIP_FA_2016_14008_23108.jpg

LM Start	2.28	Rating **	M	Issue No.	53
LM End	2.28	Issue Type +	En	Location *	LS
Category	Supplemental			GPS Latitude/Longitude	
				Start	End
Item	DWR UCIP Field Study			38.967403 °	38.967403 °
				-121.510953 °	-121.510953 °
DWR ID					
Comment Code					
Inspector Comment					
FS_ID:14008					
DS_ID:22543					
EP_NO: N/A					
Repair Type: Non-Urgent					
Crossing Status: Found					
UCIP Comments: - slide gate in inlet pipe on landside - pits on pipe due to corrosion					
FIELD_STRUCT_DESC: 36-inch corrugated-metal drainage pipe through the levee, 15.0 feet below the crown, concrete-U headwall and flap gate at outfall on the waterward end and slide gate on landside inlet (R.D. No. 1001). O&M Manual Sac 141, August 1955.					
FS Date: 5/23/2013

WS- overview of waterside of the levee.

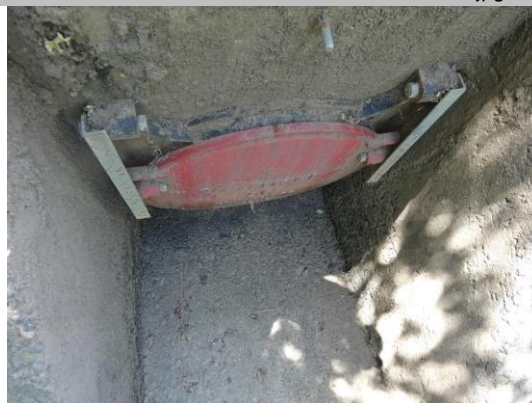
Photo 2 of 2 : UCIP_FA_2016_14008_23107.jpg

WS- outfall pipe with flap gate in concrete wing wall.

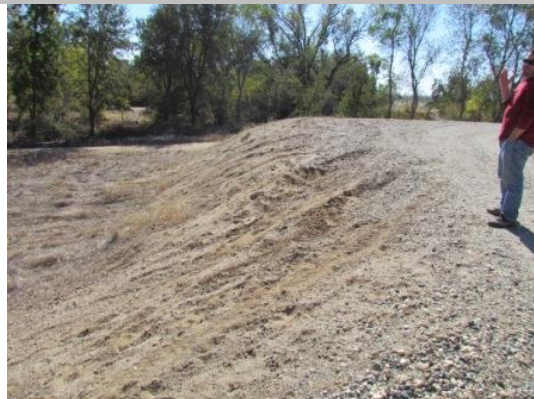
Photo 1 of 2 : FA_2016_RD1001_37_2_20160906_00003.jpg

LM Start	0.11	Rating **	M	Issue No.	2
LM End	0.11	Issue Type +	Ma	Location *	CR
Category	Earthen Levee			GPS Latitude/Longitude	
				Start	End
Item	Slope Stability			39.006569 °	39.006569 °
				-121.377037 °	-121.377037 °
DWR ID	DWR_RD1001_03_f_2013_2				
Comment Code					
S3 : Repair the levee slope damaged by vehicle traffic and prevent access where possible.					
Inspector Comment					
Rutting caused by vehicles driving up the landward levee slope.

This photo was taken from the crown of the levee facing west looking down the slope at rutting caused by vehicles driving up the landward levee slope. Fall 2015.

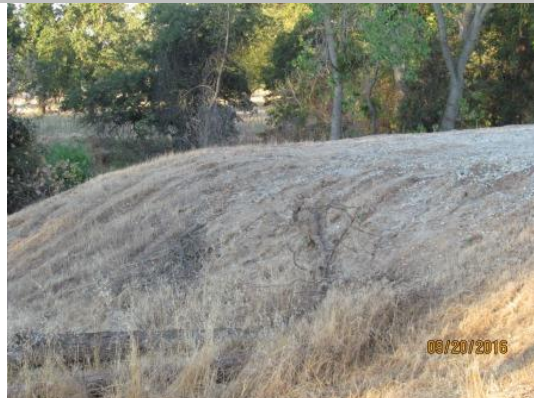
Photo 2 of 2 : FA_2016_RD1001_37_2_20160926_00039.jpg

View of the same rutting on the landside of the levee facing downstream. Fall 2016.

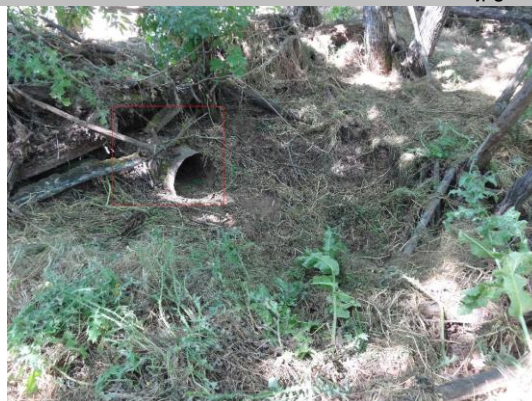
Photo 1 of 2 : UCIP_FA_2016_14128_23308.jpg

LM Start	0.88	Rating **	M	Issue No.	911
LM End	0.88	Issue Type +	En	Location *	LS
Category	Supplemental			GPS Latitude/Longitude	
				Start	End
Item	DWR UCIP Field Study			39.006508 °	39.006508 °
				-121.391086 °	-121.391086 °
DWR ID					
Comment Code					
Inspector Comment					
FS_ID:14128 DS_ID:22549 EP_NO: 958 Repair Type: Non-Urgent Crossing Status: Found UCIP Comments: - slide gate on WS not found- needs abandoned properly. FIELD_STRUCT_DESC: Abandoned 24-inch irrigation pipe through the levee.(Permit No. 958, 1944) FS Date: 5/21/2013

WS- abandoned CMP on berm of the levee.

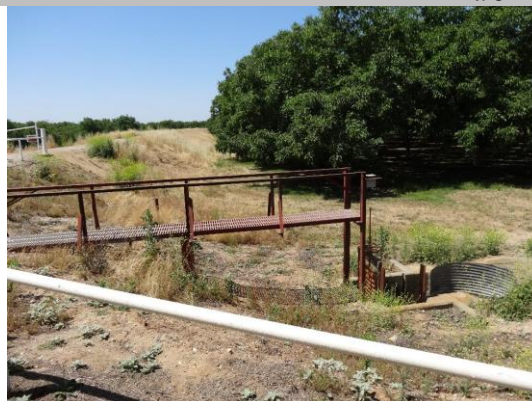
Photo 1 of 2 : UCIP_FA_2016_41727_23325.jpg

WS- steel walkway, CMP and concrete headwall

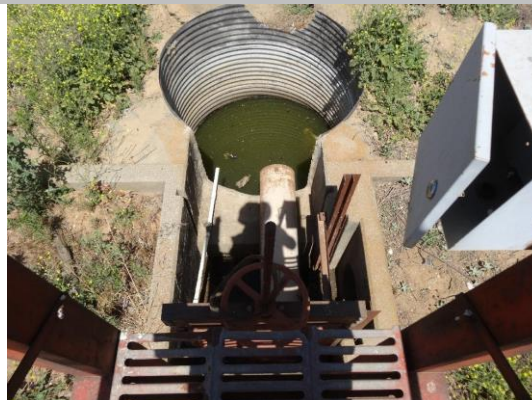
Photo 2 of 2 : UCIP_FA_2016_41727_23324.jpg

WS- CMP standpipe, pipes and concrete headwall.

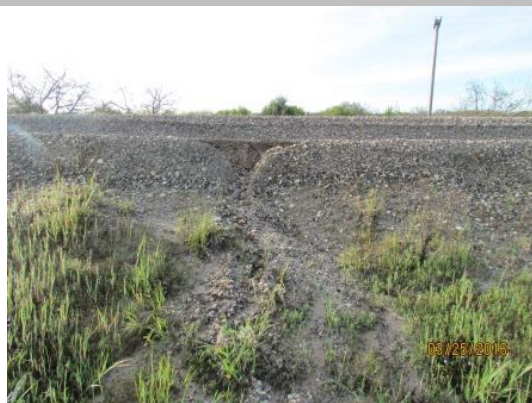
Photo 1 of 1 : FA_2016_RD1001_37_21_20160906_00013.jpg

Erosion on waterside slope. Remains as of Fall 2016.

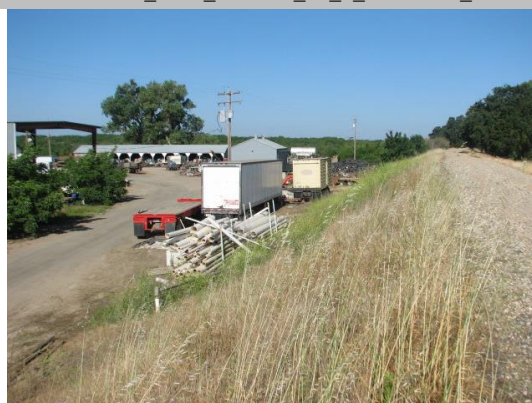
Photo 1 of 1 : FA_2016_RD1001_37_7_20160906_00008.jpg

Irrigation pipe equipment and plastic cans within the easement of the levee. Spring 2013

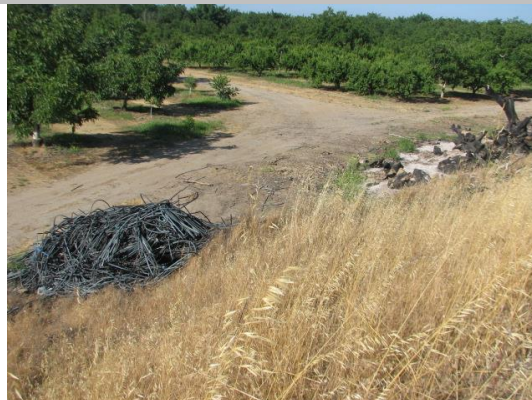
Photo 1 of 2 : FA_2016_RD1001_37_9_20160906_00010.jpg

Drip irrigation tubing within the easement of the levee. Spring 2013

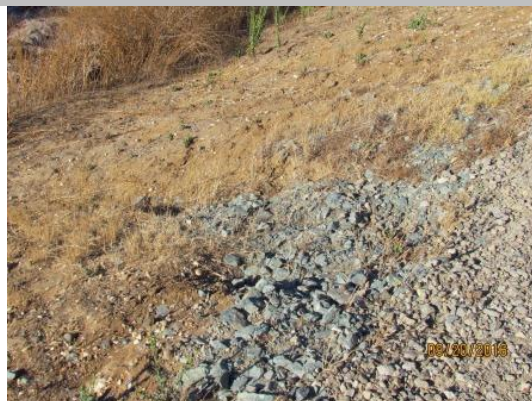
Photo 1 of 1 : FA_2016_RD1001_37_31_20160926_00055.jpg

View of erosion in the landside levee slope looking downstream. Fall 2016.

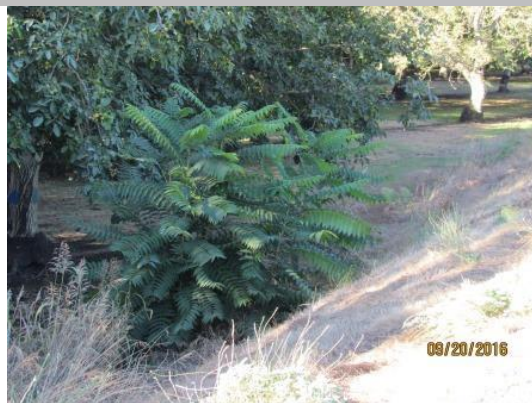
Photo 1 of 1 : FA_2016_RD1001_37_32_20160926_00056.jpg

View of starter tree with diameter less than 4". Fall 2016.

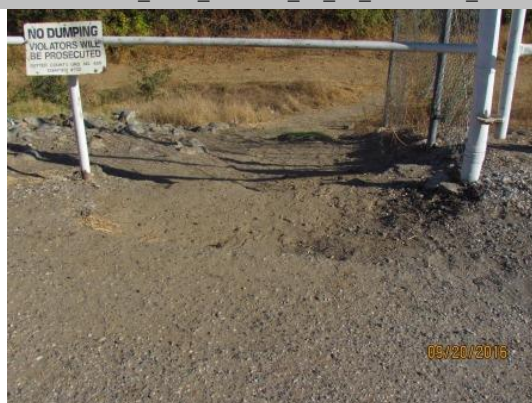
Photo 1 of 1 : FA_2016_RD1001_37_40_20160926_00058.jpg

View of slope instability on the waterside at gate caused by foot traffic. Fall 2016.

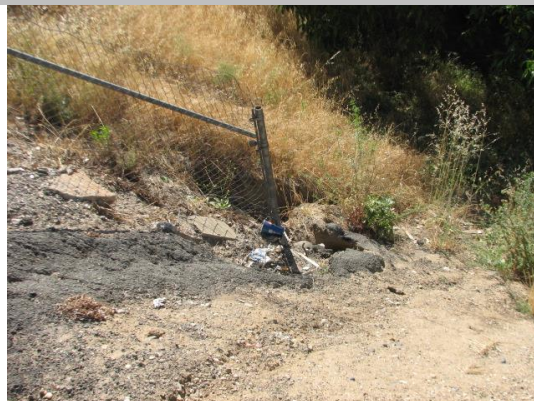
Photo 1 of 2 : FA_2016_RD1001_37_38_20160906_00022.jpg

Erosion caused by run off from the roadway. Spring 2013

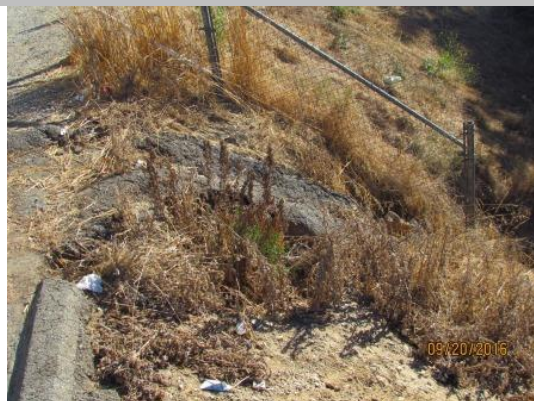
Photo 2 of 2 : FA_2016_RD1001_37_38_20160926_00057.jpg

Erosion caused by run off from the roadway still exist. Fall 2016.

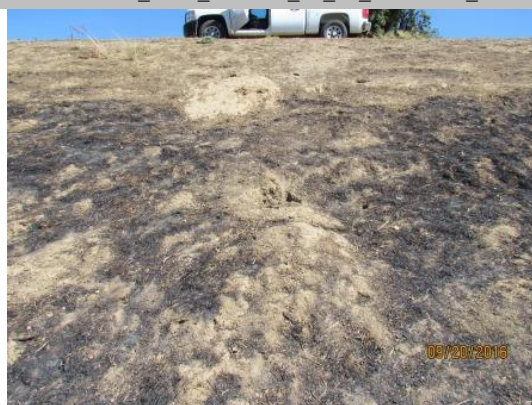
Photo 1 of 1 : FA_2016_RD1001_37_48_20160926_00060.jpg

View of existing rodent hole that are no longer active on the landside slope. Fall 2016.

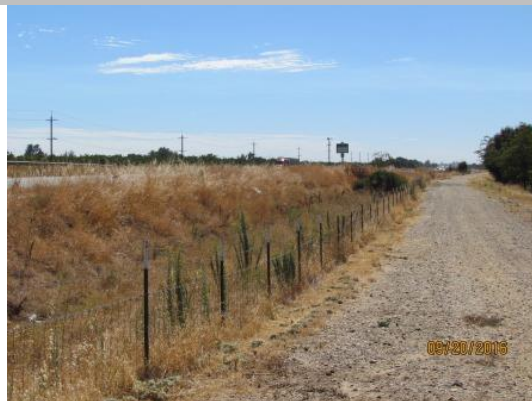
Photo 1 of 1 : FA_2016_RD1001_37_49_20160926_00061.jpg

View of fence on the landside hinge point looking downstream. Fall 2016.

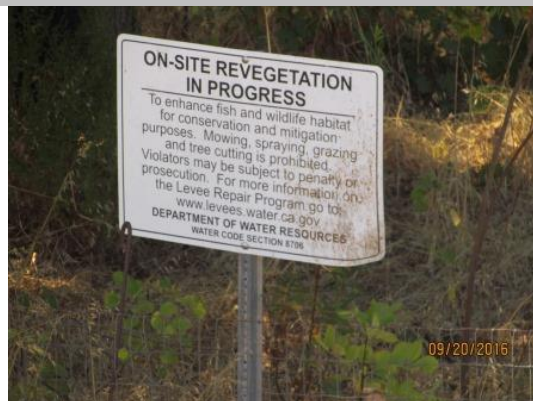
Photo 1 of 1 : FA_2016_RD1001_37_50_20160926_00063.jpg

Revegetation has been done in this area on the waterside. Visibility is minimal. Fall 2016.

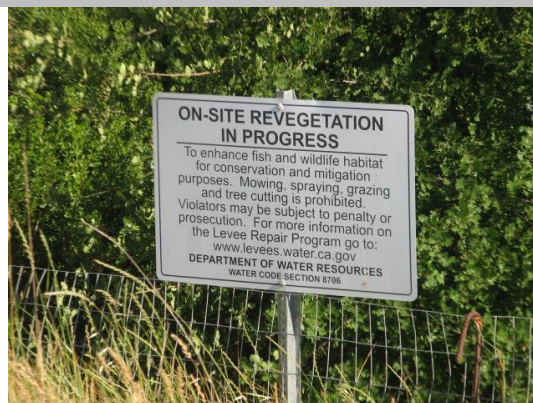
Photo 1 of 1 : FA_2016_RD1001_37_25_20160906_00015.jpg

Revegetation site in progress. Spring 2013

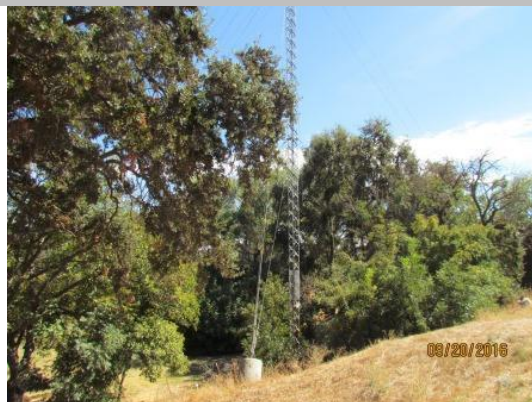
Photo 1 of 1 : FA_2016_RD1001_38_19_20160926_00062.jpg

View of power pole and guy wire on the levee slope. Fall 2016.

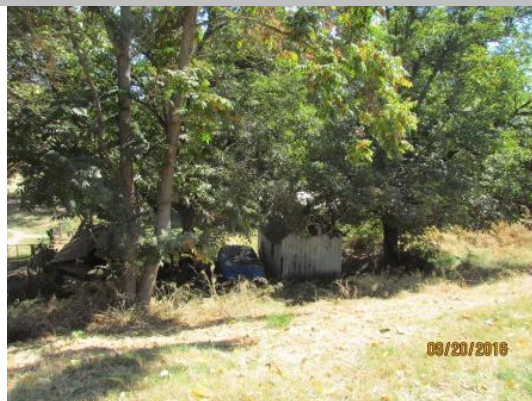
Photo 1 of 1 : FA_2016_RD1001_38_34_20160926_00066.jpg

View of a shed in the easement of the landside levee. Fall 2016.

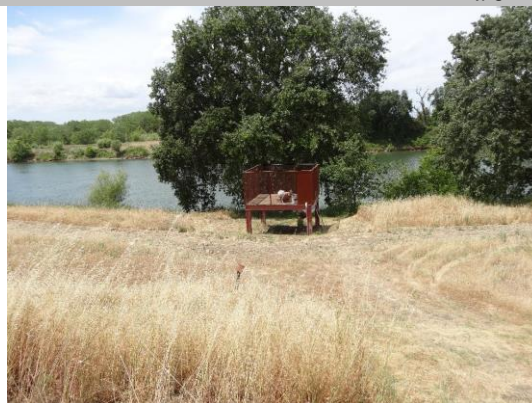
Photo 1 of 2 : UCIP_FA_2016_14604_24107.jpg

WS- slanted pump station on steel platform on levee berm.

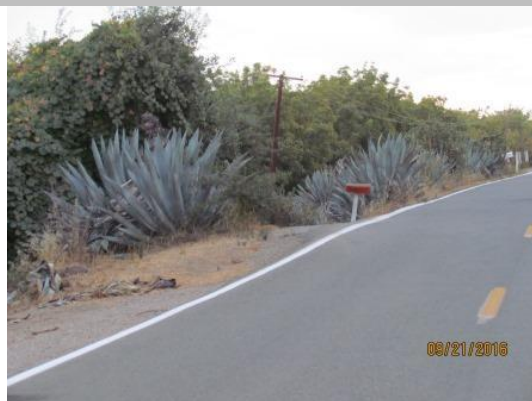
Photo 1 of 1 : FA_2016_RD1001_38_17_20160926_00078.jpg

View of landscaping on the landside shoulder and slope looking downstream. Fall 2016.

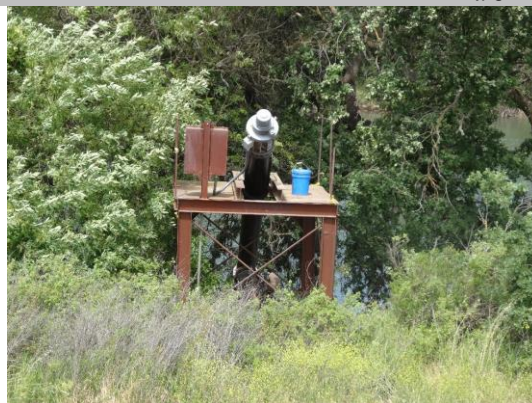
Photo 1 of 2 : UCIP_FA_2016_14563_24002.jpg

WS- slanted pipe in steel structure on river bank.

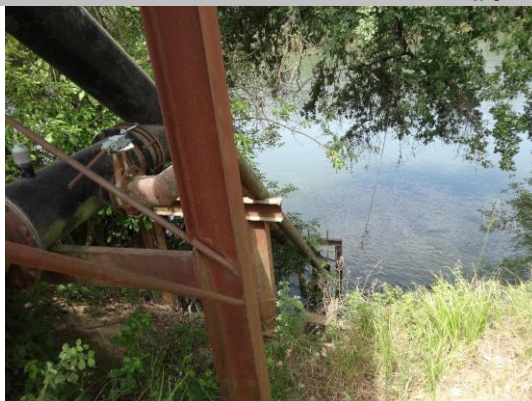
Photo 2 of 2 : UCIP_FA_2016_14563_24001.jpg

WS- inlet pipe and main pipe in pump station on river bank.

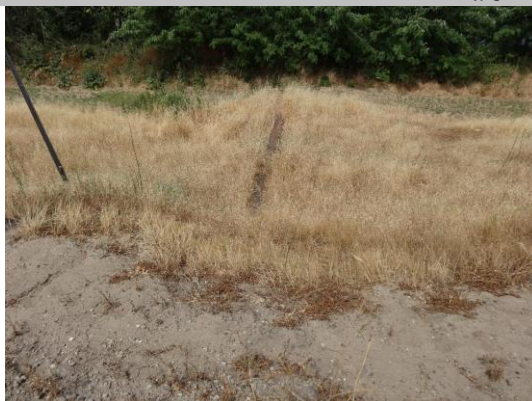
Photo 1 of 2 : UCIP_FA_2016_14544_23966.jpg

WS- damaged pipe with holes, cracks on levee slope. River bank is not visible due to dense vegetation (top)

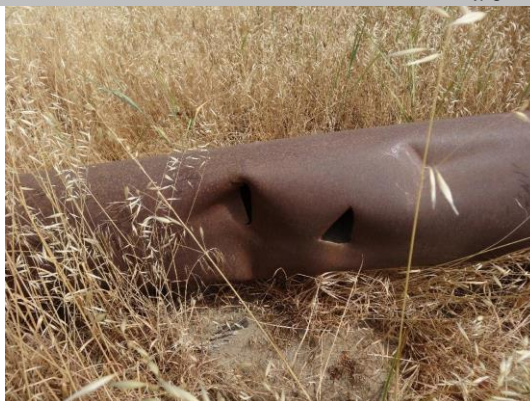
Photo 2 of 2 : UCIP_FA_2016_14544_23965.jpg

WS- abandoned damaged pipe with holes, cracks on levee slope.

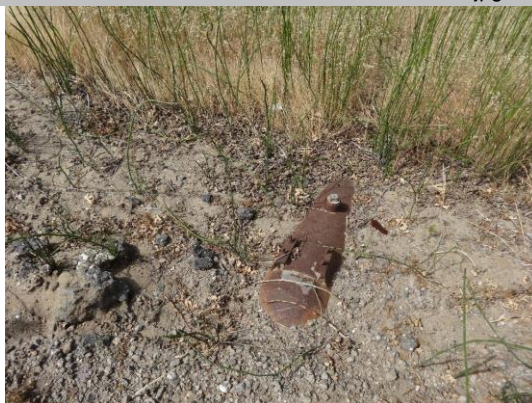
Photo 2 of 2 : UCIP_FA_2016_14627_24133.jpg

WS- exposed pipe on levee slope.

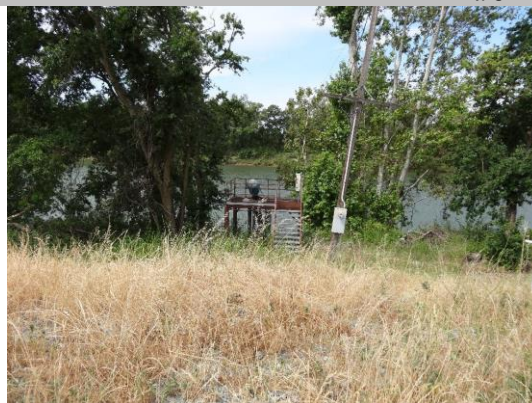
Photo 1 of 2 : UCIP_FA_2016_41723_23977.jpg

WS- slant pump on steel structure in river bank.

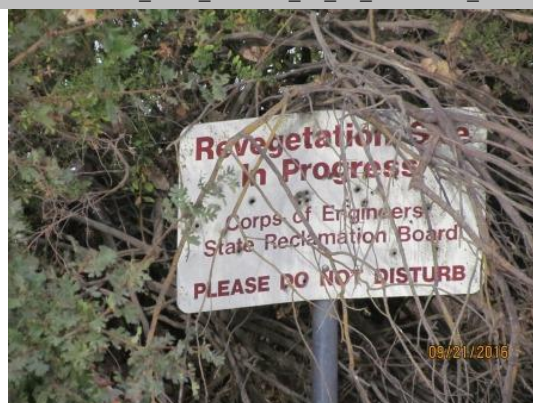
Photo 1 of 1 : FA_2016_RD1001_38_50_20160927_00087.jpg

Vegetation has been introduced in this area. Photo taken Fall 2016.

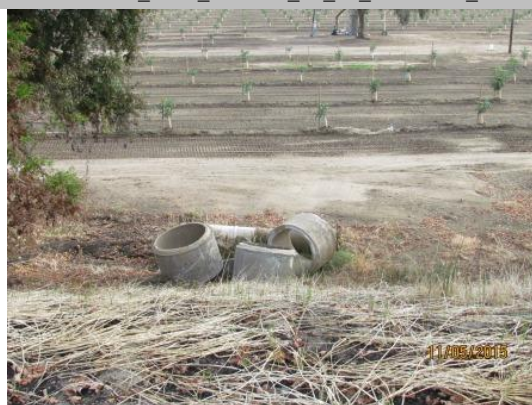
Photo 1 of 1 : FA_2016_RD1001_38_41_20160906_00022.jpg

View of the material at the landside levee toe.

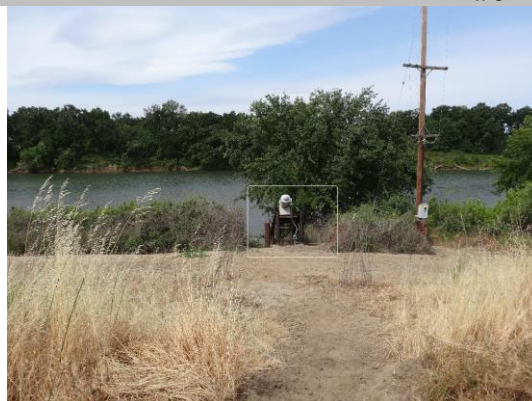
Photo 1 of 2 : UCIP_FA_2016_14548_23970.jpg

WS- slant pump on river bank.

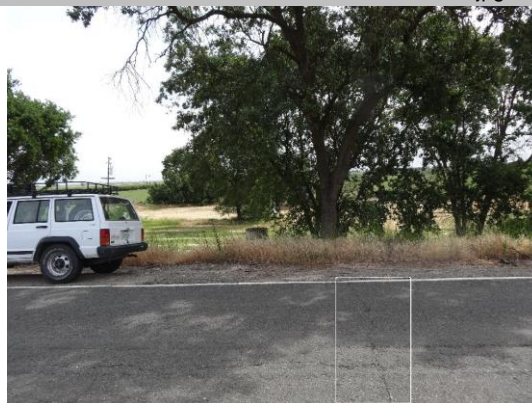
Photo 2 of 2 : UCIP_FA_2016_14548_23969.jpg

Levee Crown- surface crack along pipe crossing. Needs more investigation.

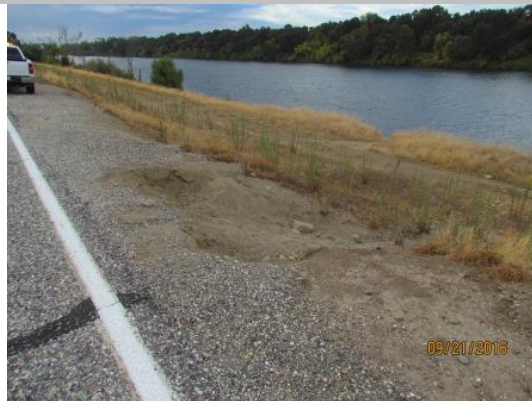
Photo 1 of 1 : FA_2016_RD1001_38_54_20160927_00089.jpg

View of vehicle ruts in levee shoulder on the waterside looking downstream. Fall 2016.

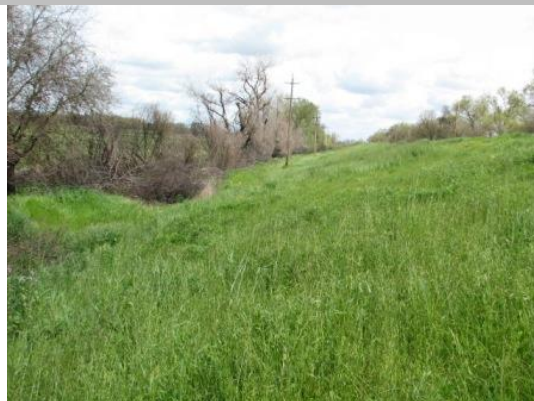
Photo 2 of 2 : FA_2016_RD1001_39_5_20160906_00002.jpg

Poles at the land side toe.

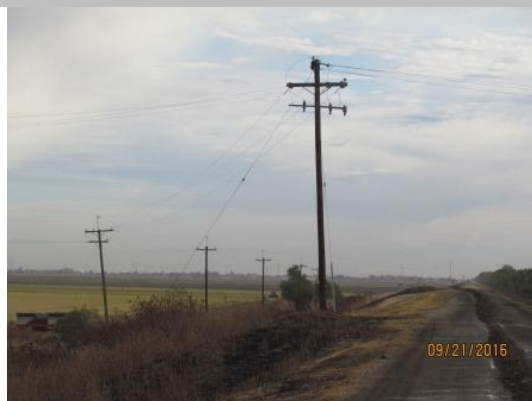
Photo 2 of 2 : FA_2016_RD1001_39_6_20160923_00033.jpg

View of pole on land side shoulder looking down stream. Fall 2016.

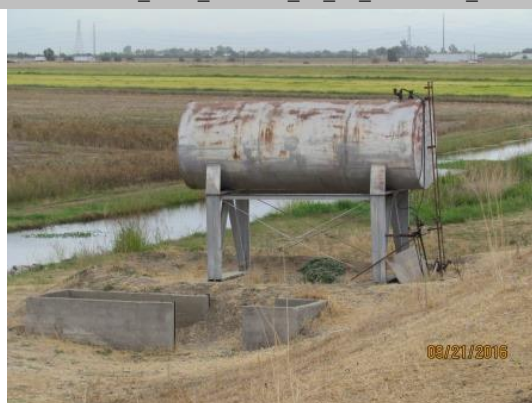
Photo 1 of 1 : FA_2016_RD1001_39_10_20160923_00036.jpg

View of fuel tank at landside levee toe. Fall 2016.

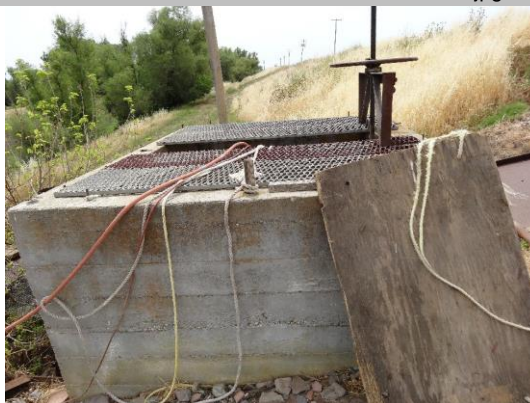
Photo 2 of 2 : UCIP_FA_2016_14484_23898.jpg

WS- slide gate in concrete box on levee toe.

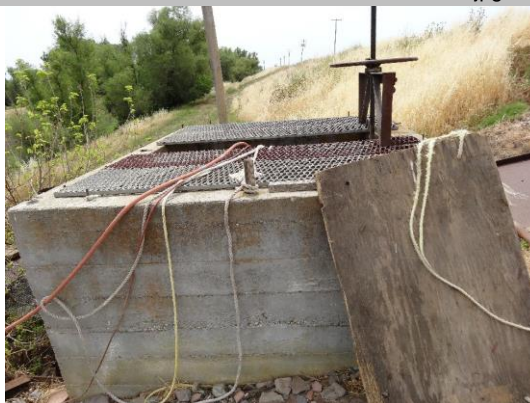
Photo 2 of 2 : UCIP_FA_2016_14472_23890.jpg

WS- slide gate in concrete box on levee toe

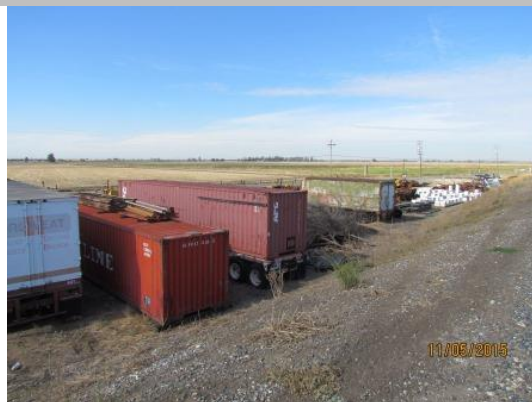
Photo 1 of 1 : FA_2016_RD1001_40_3_20160906_00001.jpg

View of the equipment at the landside levee toe.

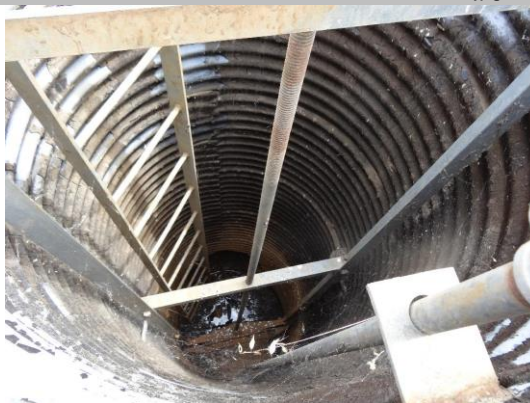
Photo 2 of 2 : UCIP_FA_2016_14244_23466.jpg

WS- slide gate, air vent pipe in CMP riser on levee slope.

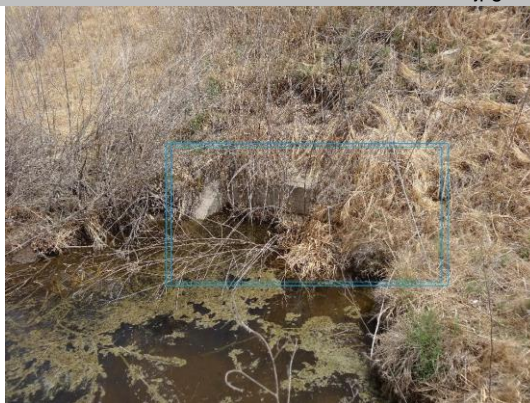
Photo 2 of 2 : UCIP_FA_2016_14223_23444.jpg

LS- concrete wing wall on levee toe

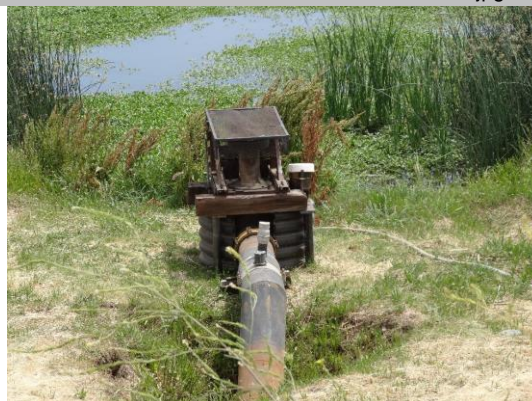
Photo 1 of 2 : UCIP_FA_2016_50692_23427.jpg

WS- pump and pipe on river bank

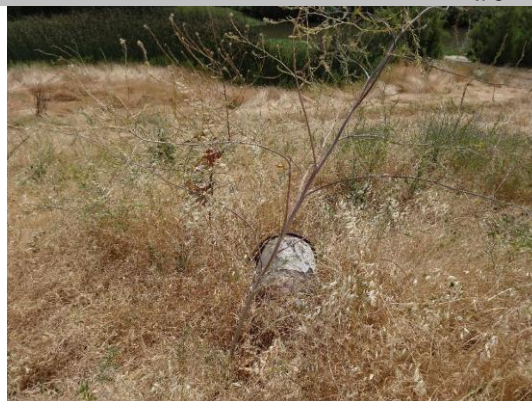
Photo 1 of 2 : UCIP_FA_2016_41674_23382.jpg

WS- an abandoned pipe on levee slope

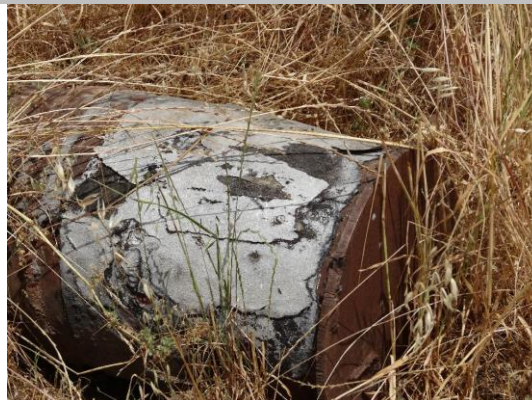
Photo 2 of 2 : UCIP_FA_2016_41674_23381.jpg

WS- an abandoned end capped pipe on levee slope

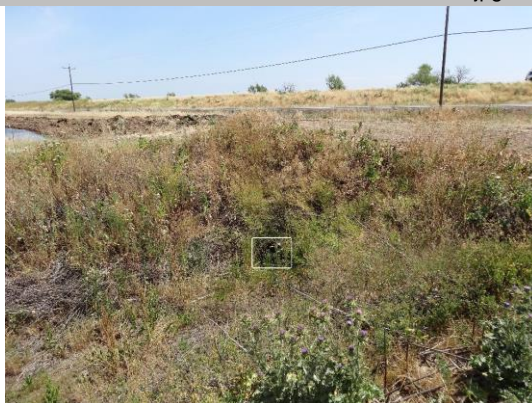
Photo 2 of 2 : UCIP_FA_2016_14167_23395.jpg

LS- CMP opens in irrigation ditch.

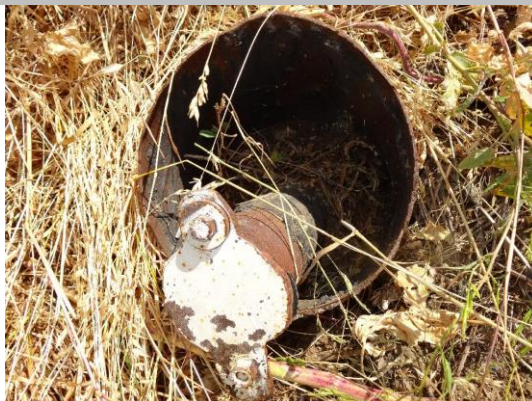
Photo 2 of 2 : UCIP_FA_2016_13523_22120.jpg

WS- gap between two pipes needs to be filled.

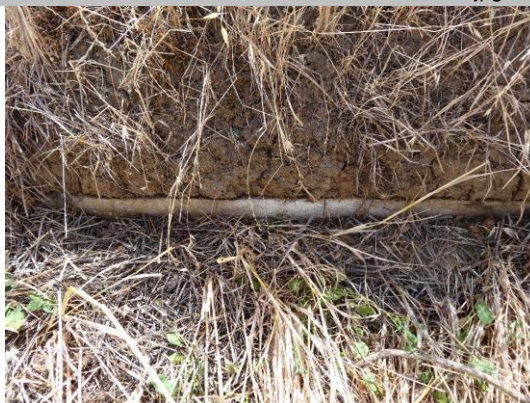
Photo 2 of 2 : UCIP_FA_2016_13509_22085.jpg

LS- almost buried concrete headwall. Only upper portion of the wall is visible.

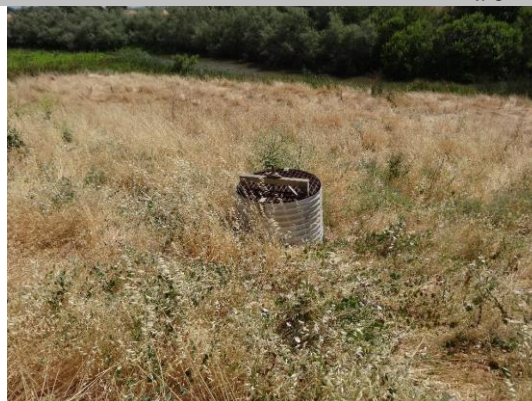
Photo 1 of 2 : UCIP_FA_2016_50699_22046.jpg

WS- slide gate, air vent in CMP riser on levee slope

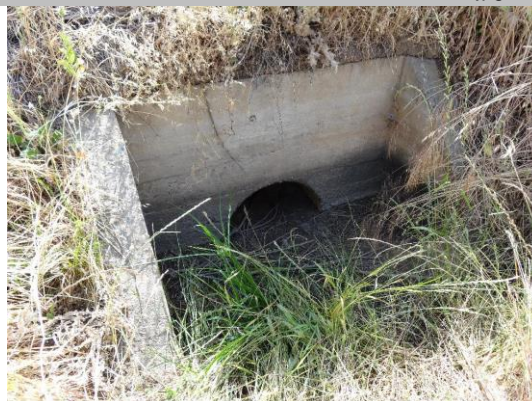
Photo 2 of 2 : UCIP_FA_2016_50699_22045.jpg

LS- CMP in concrete head/wing wall outlet

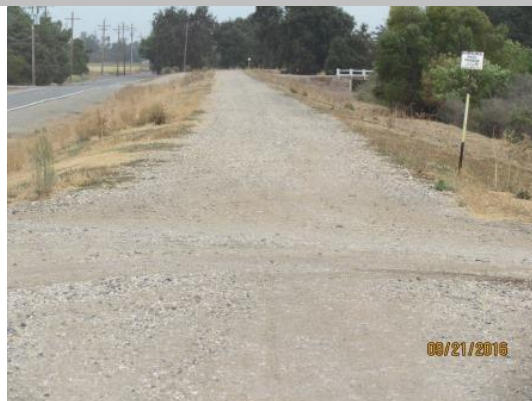
Photo 1 of 1 : FA_2016_RD1001_40_7_20160923_00042.jpg

View of crown where there is cross traffic looking upstream. Monitor this area and fix as needed.

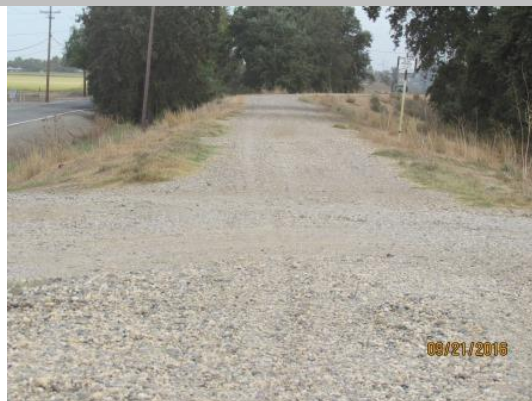
Photo 1 of 1 : FA_2016_RD1001_40_19_20160923_00043.jpg

View of crown where there is cross traffic looking upstream. Monitor this area and fix as needed.

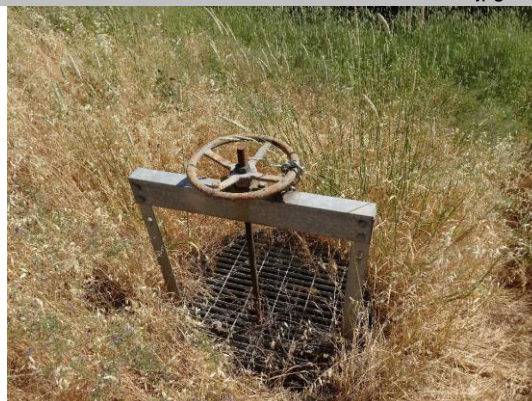
Photo 1 of 2 : UCIP_FA_2016_41724_22034.jpg

WS- slide gate in CMP riser.
